Focus CR Rear Anti-Tip

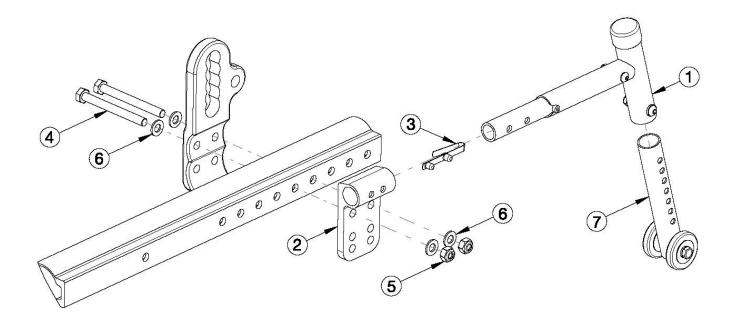
Anti-Tip assemblies are based on rear wheel size. Anti-Tip Receivers are installed on Focus chairs. Receivers are not needed when retrofitting anti-tips to a chair unless removing the Vent Tray and replacing the Vent Tray Anti-tips with the Focus CR Rear Anti-tips.
